EVALUATION OF RUST COMPATIBLE PRIMERS FOR MARINE APPLICATIONS

MAY 1984

Prepared by
RENSSELAER POLYTECHNIC INSTITUTE
IN COOPERATION WITH
AVONDALE SHIPYARDS, INC.

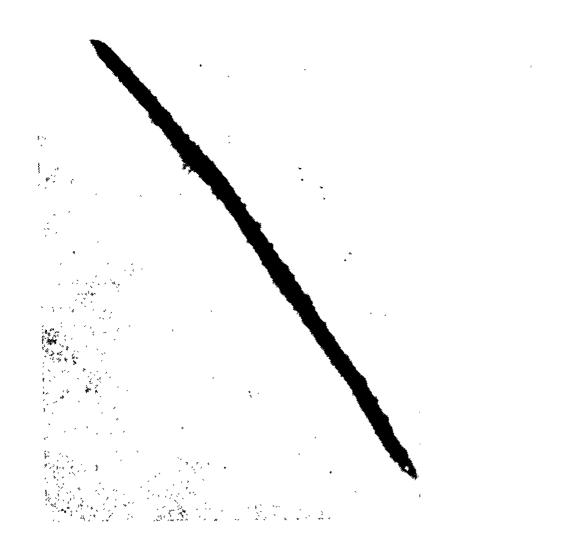
3.8 Condition of the solvent based epoxy coating after 1500 hours immersion in salt water (magnification approx. 3X).

As with the salt spray test, the mastics gave the most promising results with the solvent based epoxy again being the best. The scribed edge of the latex base material appear to be deteriorating with slight discoloration at the edge interface.

Figure 3.7 shows the condition of the water base epoxy and the latex mastic systems. Figure 3.8 shows the condition of solvent based epoxy system. Figure 3.9-3.12 show the condition of some of the other materials as they appeared after test.

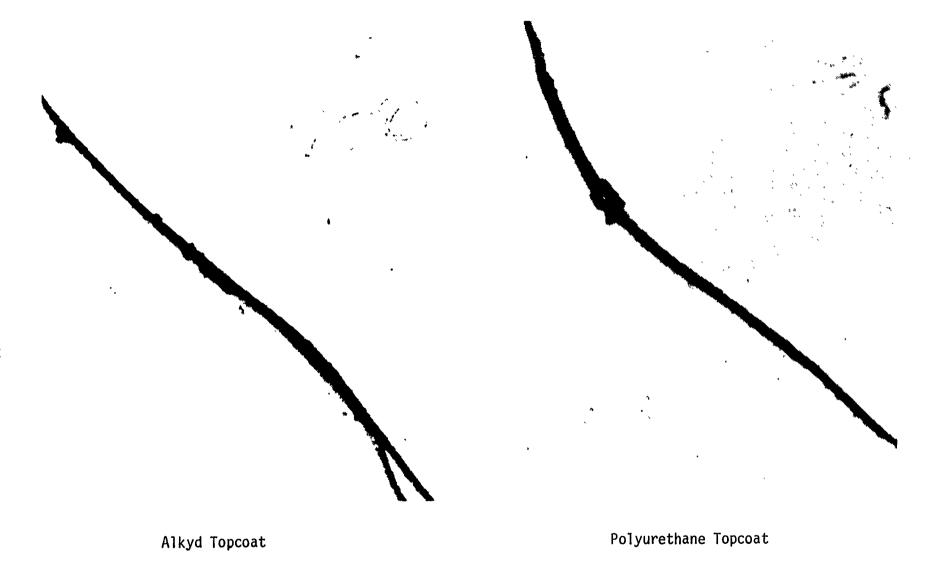
Figure 3.10 Condition of urethane primer with various top coats after 1500 hours immersion in salt water (magnification approx. 3X).

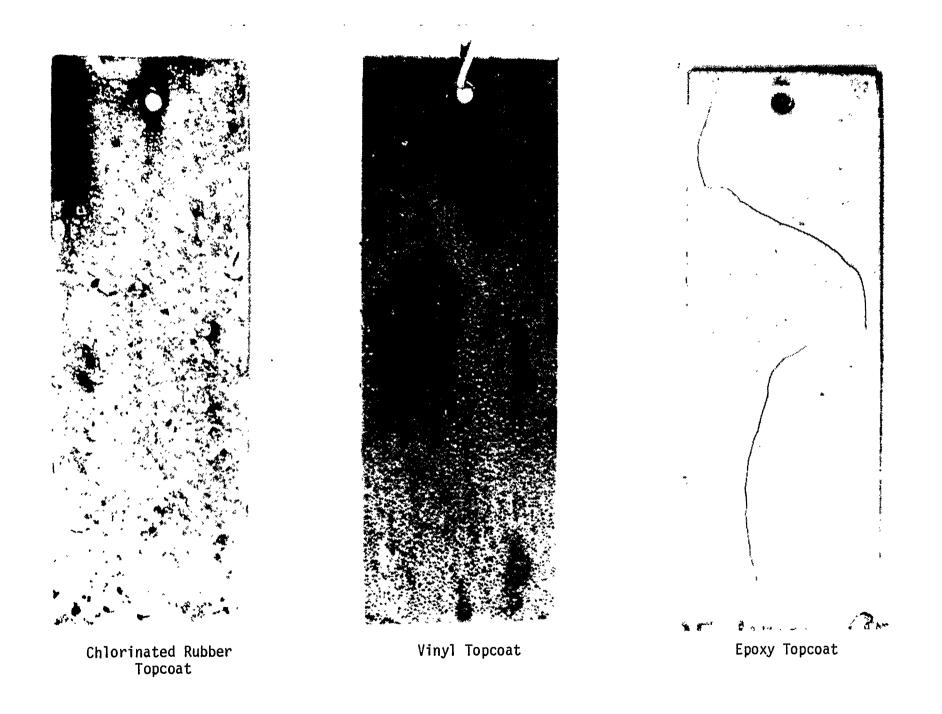
Figure 3.14 Condition of the Latex conversion primer after 50 cycles of

One specimen which did not appear good in the other tests gave surprisingly good results in this evaluation. The Latex rust converter with an epoxy top coat appeared unchanged. However, after it had been setting in the laboratory for approximately 500 hours, the coating cracked and disbonded from the surface, as seen in Figure 3.14.

Figure 3.13-3.17 show the condition of the test specimens after 50 pressure cycles at 20 psi. As with the other tests, the mastics were the most encouraging with the polyurethane primer coated specimens being second best.

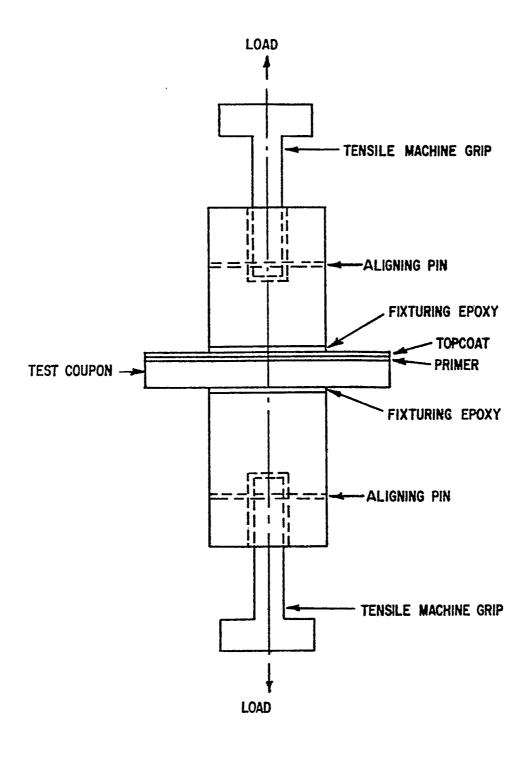
Figure 3.18 Schematic Diagram of the Essential parts of the Bond Strength Apparatus

The tensile strength was recorded at the time that the cylinder was pulled from the coating and the location of failure was noted.

The position of fracture is very important in this test. Separation in the fixturing epoxy gave a minimum value of bond strength. That is, the bond strength of the coating system is greater than that shown when fracture occurred. Separation in the top coat, or in the interface between the primer and the metal substrate gave an indication of the strength of the coating system. The criteria are as follows:
